**SEWAGE COLLECTION SYSTEM INSPECTION FORM
City of Alameda, CA**

Inspection Date: **April 2 – 3, 2009**

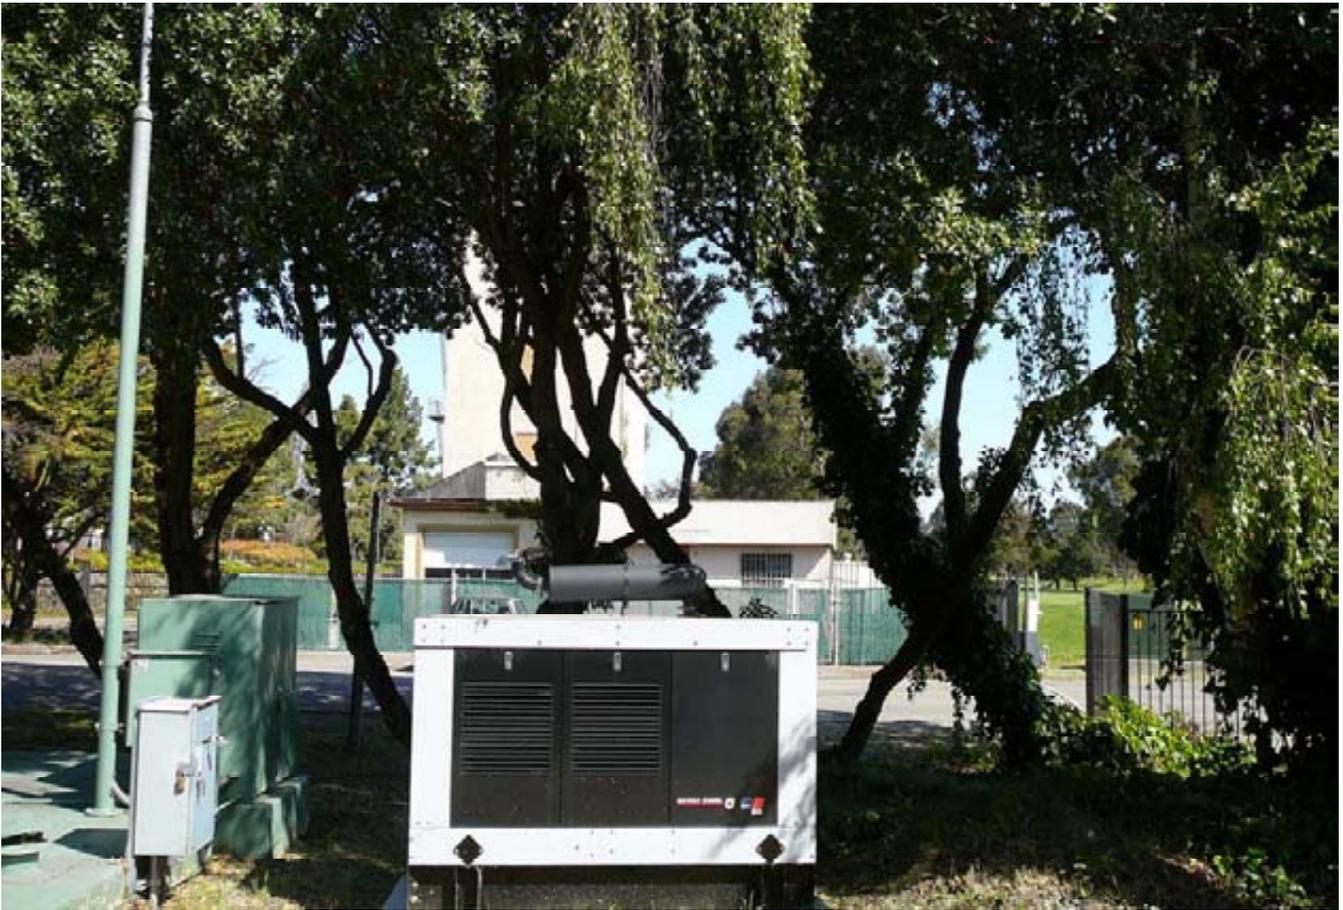
- BFI (Photos 1 and 2) – located on Bay Farm Island next to a golf course. This station is not fenced. SCADA is present. A spill occurred on 6/24/05 due to a power failure. A generator has since been installed. City staff identified where the spill entered a storm drain inlet.

Alameda Photo 1 - BFI pump station

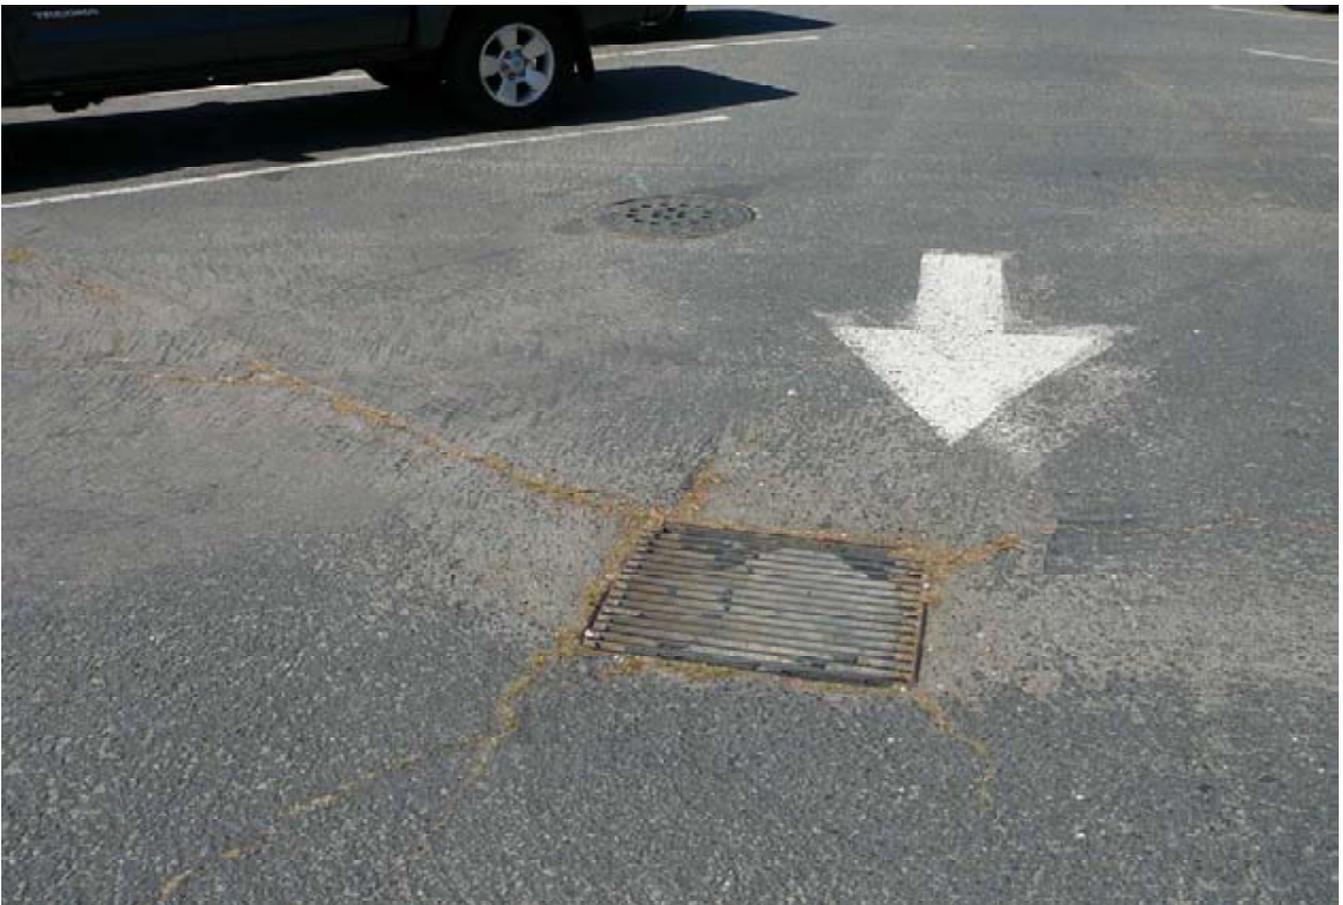
Alameda Photo 2 - Location of overflow from BFI pump station

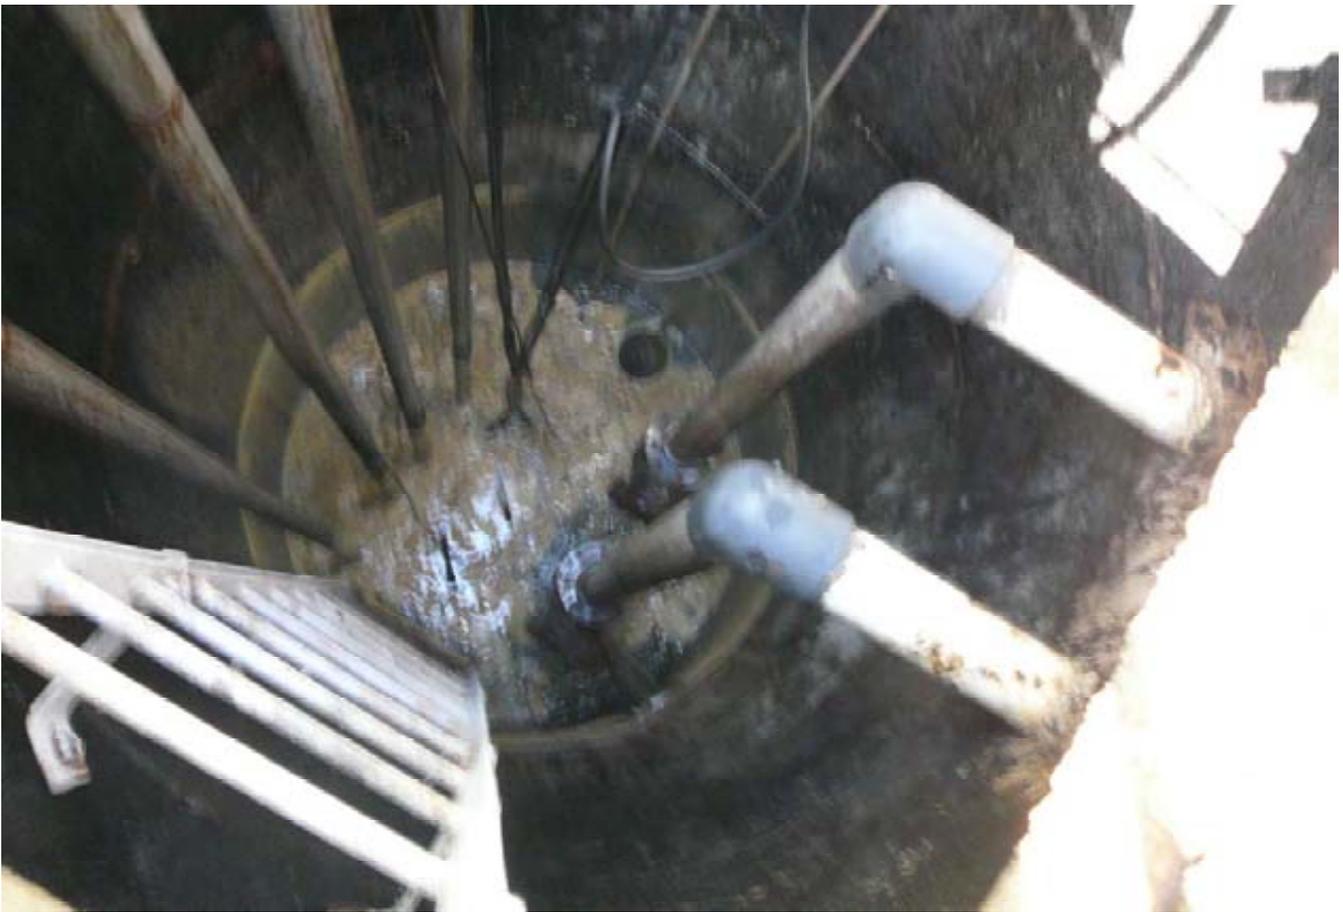
- Dublin (Photos 3 and 4) – located in a residential area. This station is not fenced. SCADA is located across the street. Some grease visible in wet well.

Alameda Photo 3 - Dublin pump station wet well

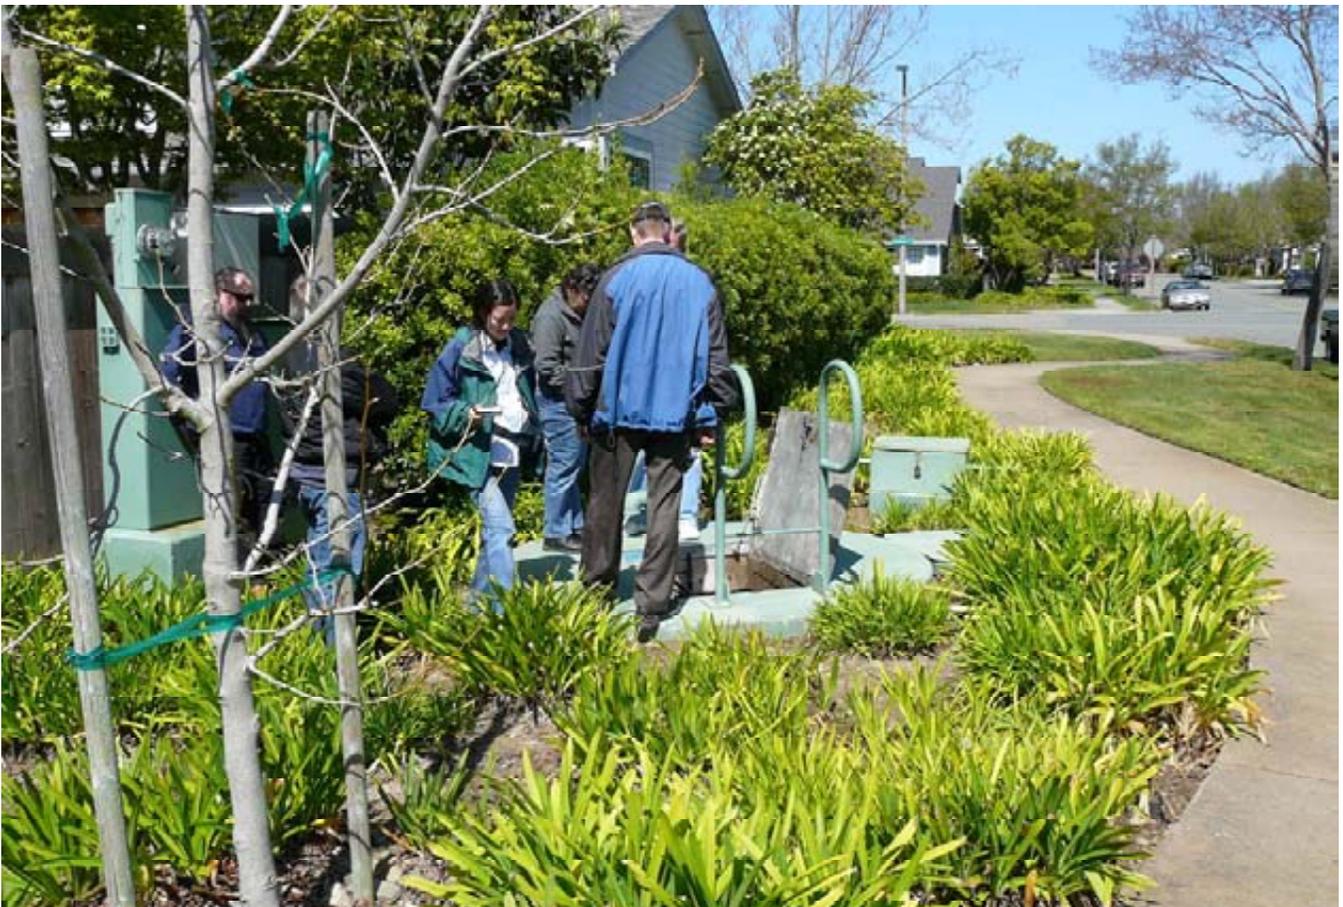
Alameda Photo 4 - Dublin pump station

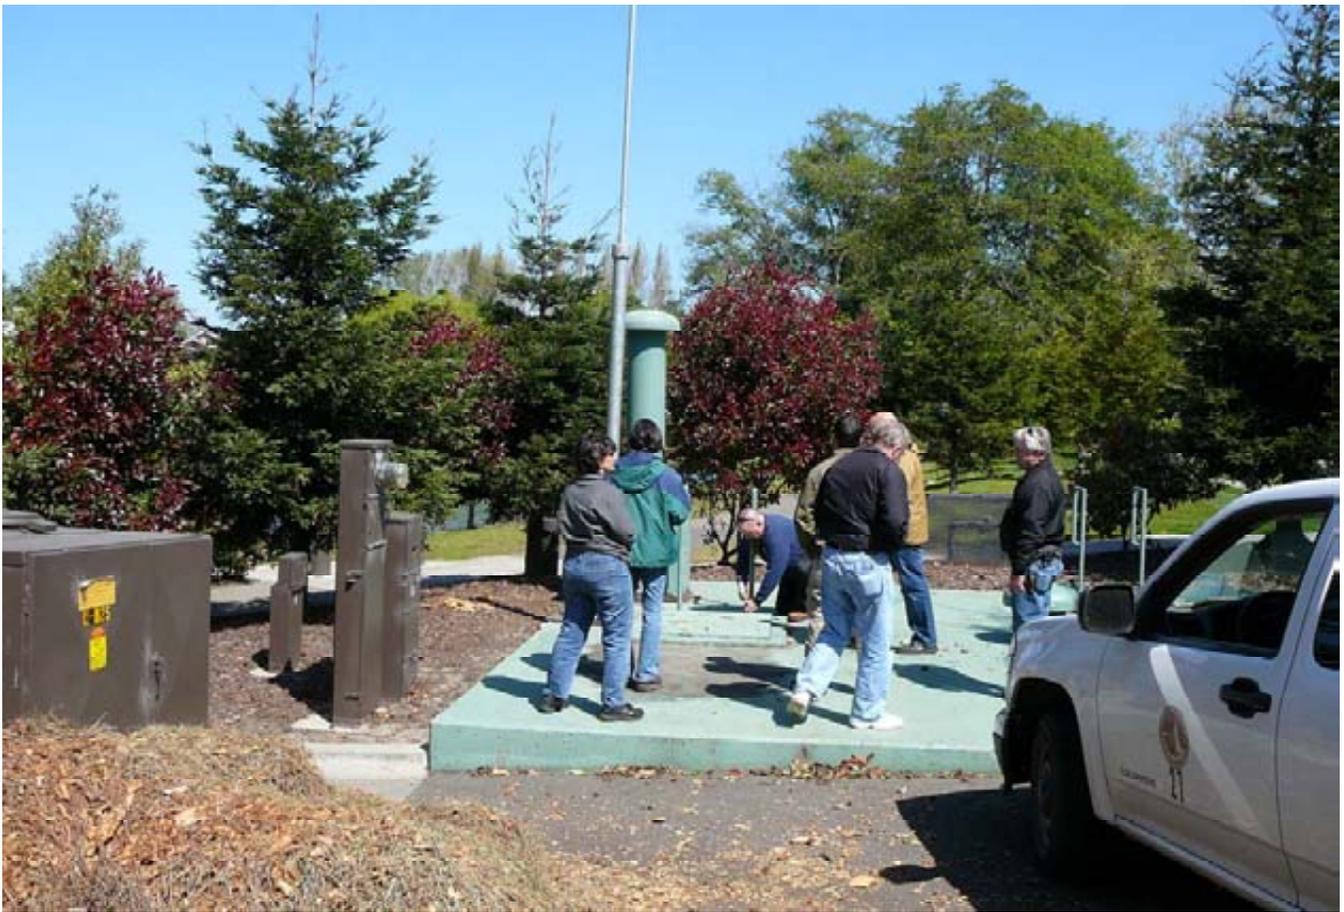
- Catalina (Photos 5 and 6) – located next to a lagoon. This station is not fenced. SCADA is present. A contractor cleans the wet well about every two years.

Alameda Photo 5 - Catalina pump station

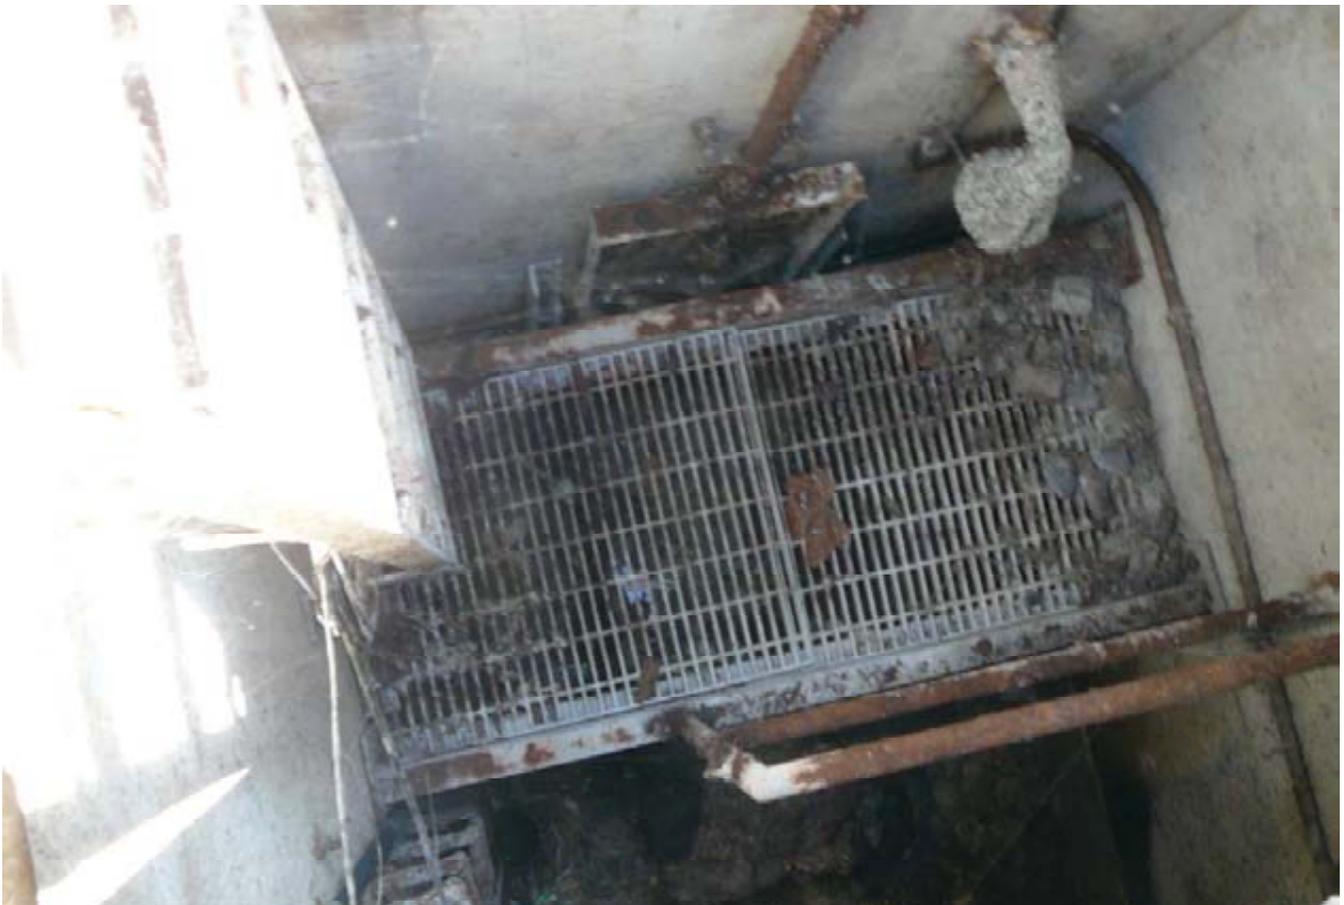
Alameda Photo 6 - Catalina pump station wet well

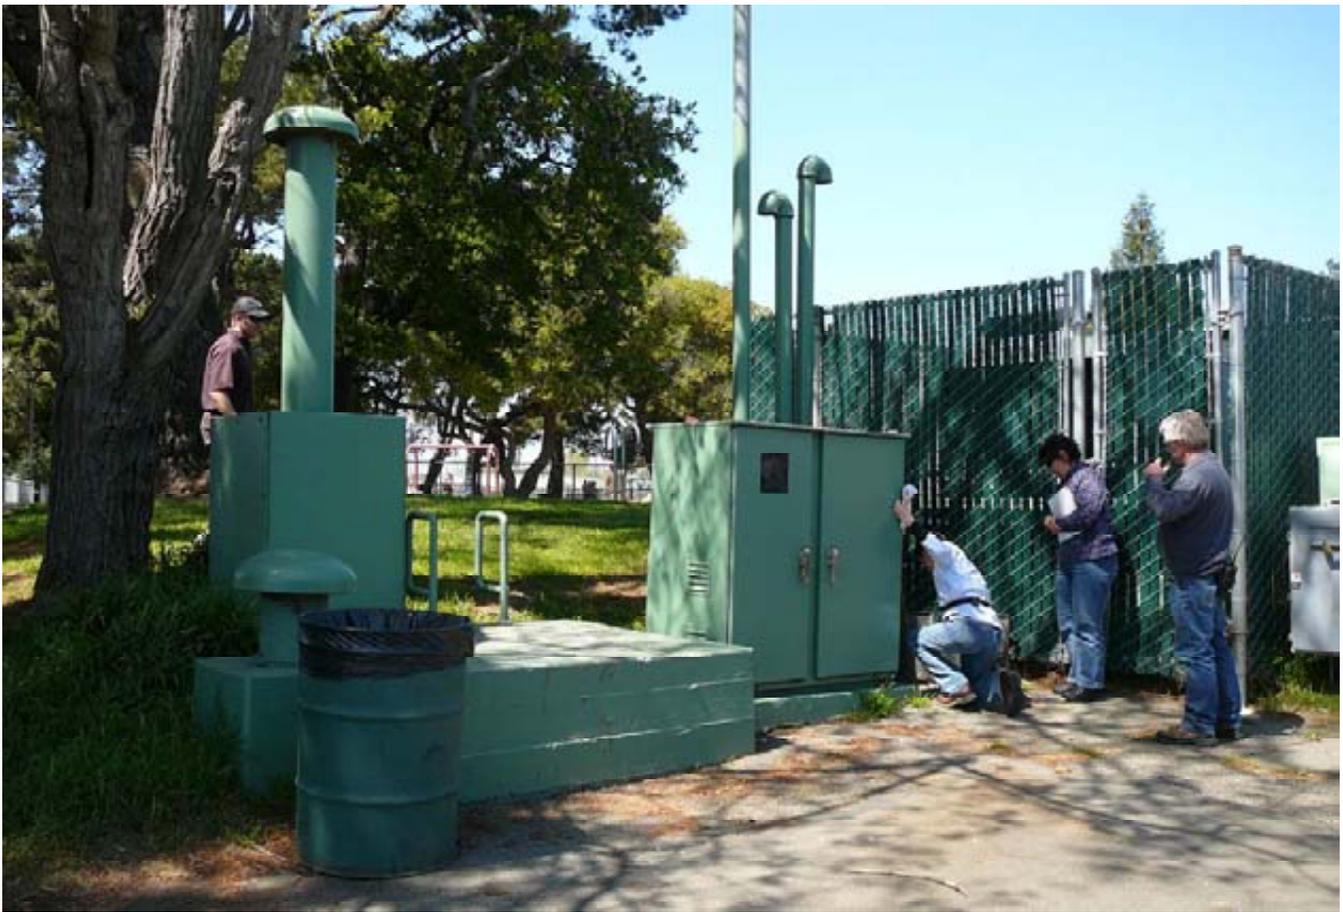
- 8th and Portola (Photo 7) – located next to a park and children's play area. This is the largest pump station. Only the generator is fenced. SCADA is present. The incoming gravity main failed at this location (date unknown). City staff stated that the main failure did not cause a spill. However, a spill did occur due to an operator error when vactoring out the wet well during the main failure. The City did not report this spill because a contractor was operating the vactor.

Alameda Photo 7 - 8th and Portola pump station

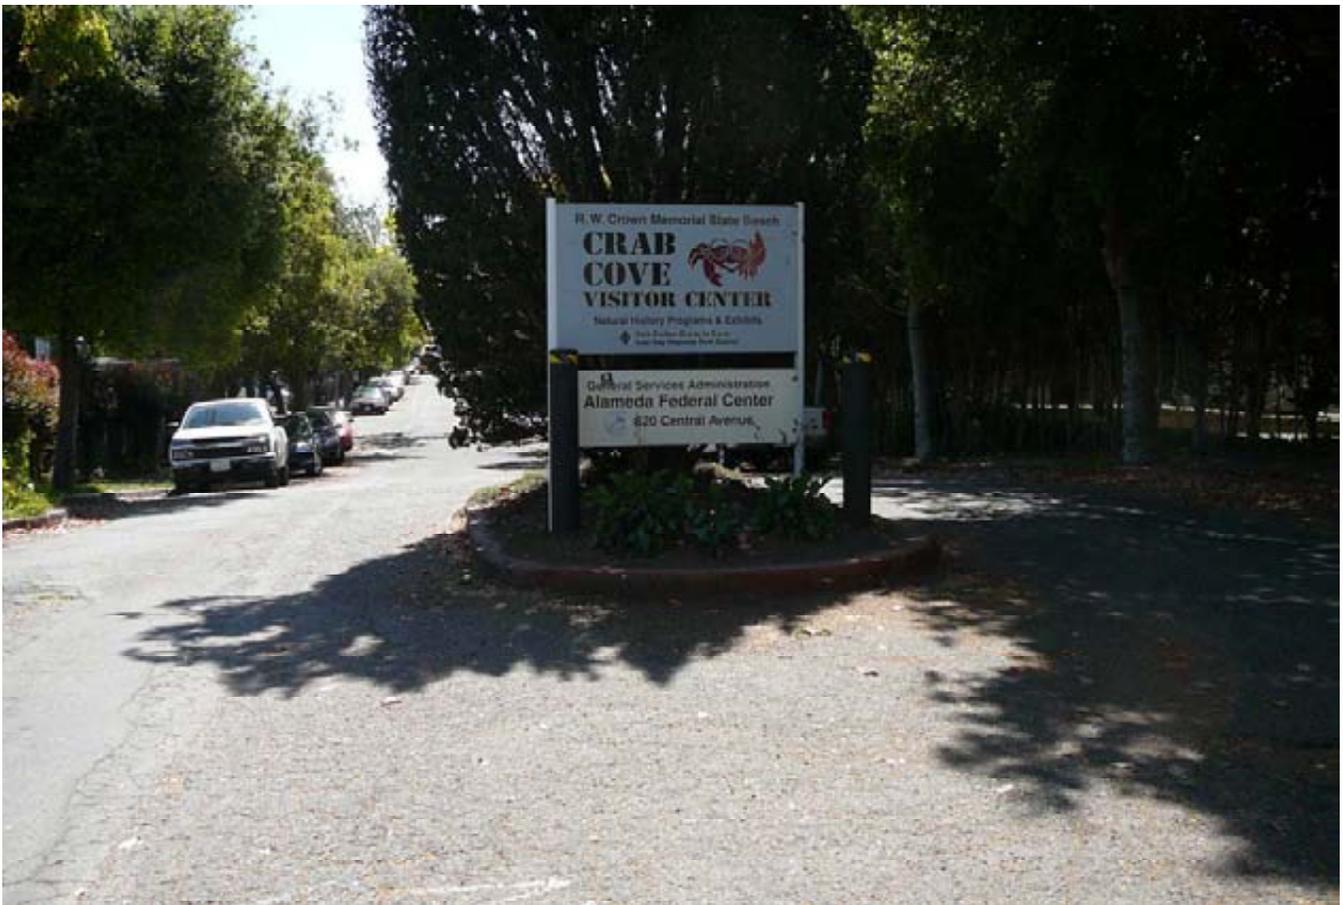
Alameda Photo 8 - Spill site at Alameda Federal Center

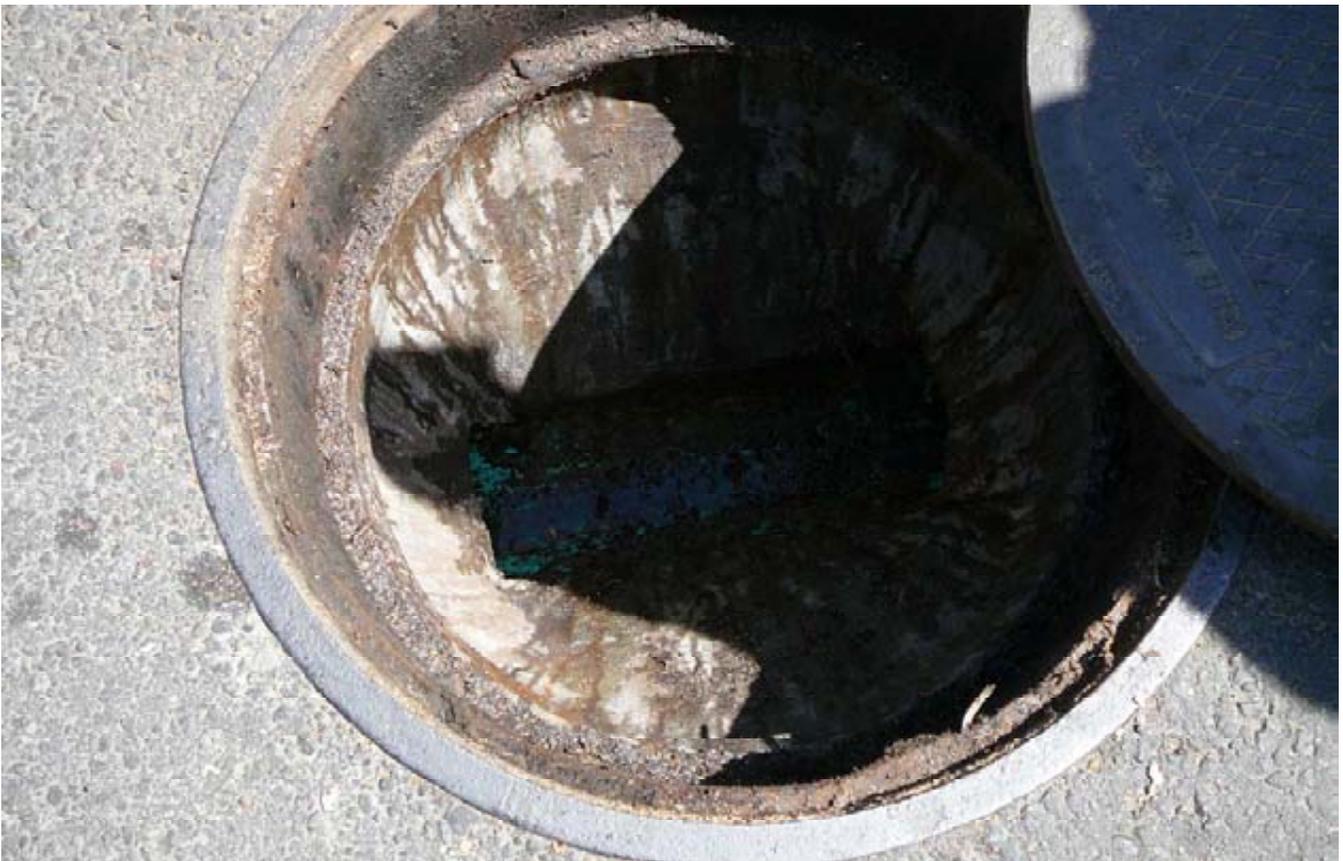
Alameda Photo 9 - Spill site at Alameda Federal Center - Manhole that overflowed

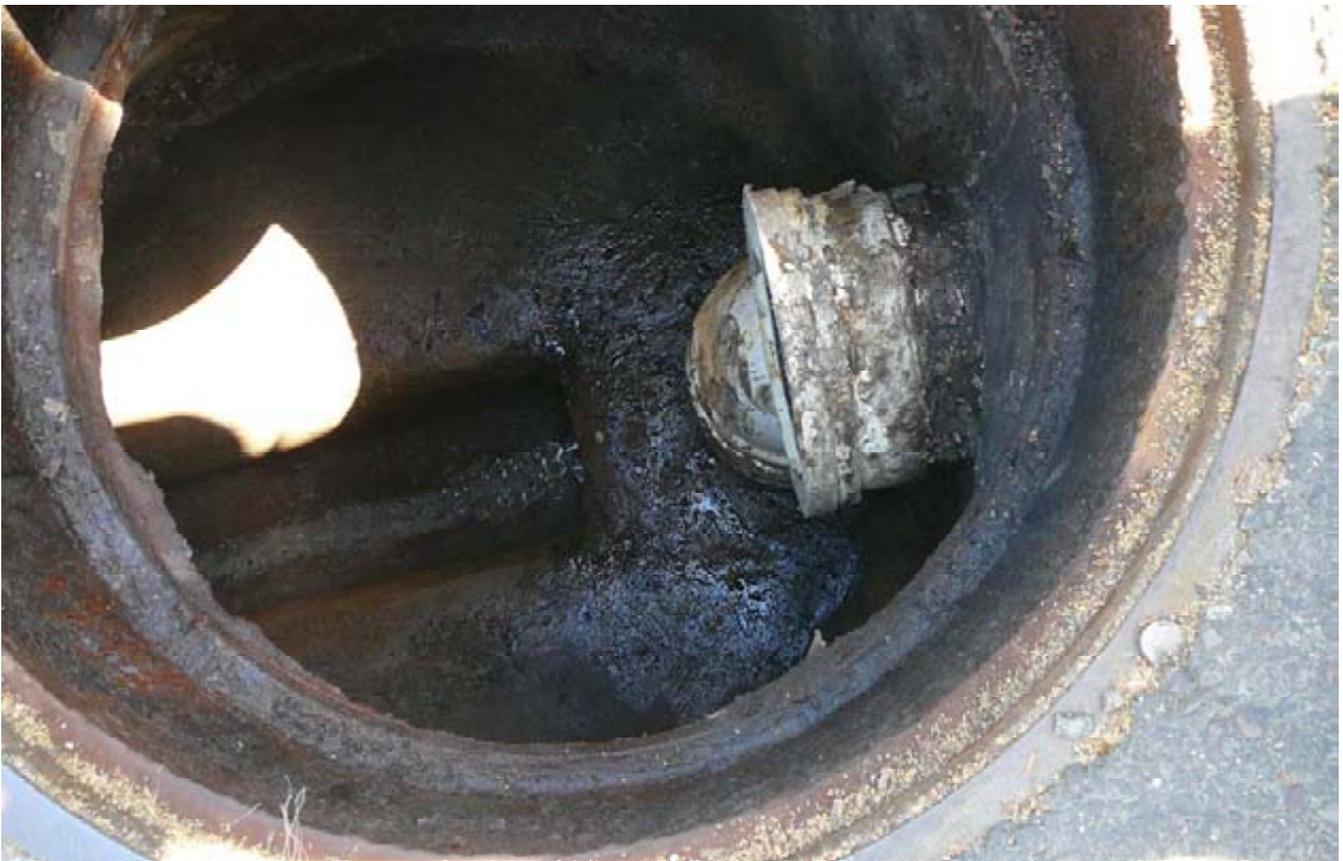
Alameda Photo 10 - Spill site at Alameda Federal Center - Second manhole showing pipe fix

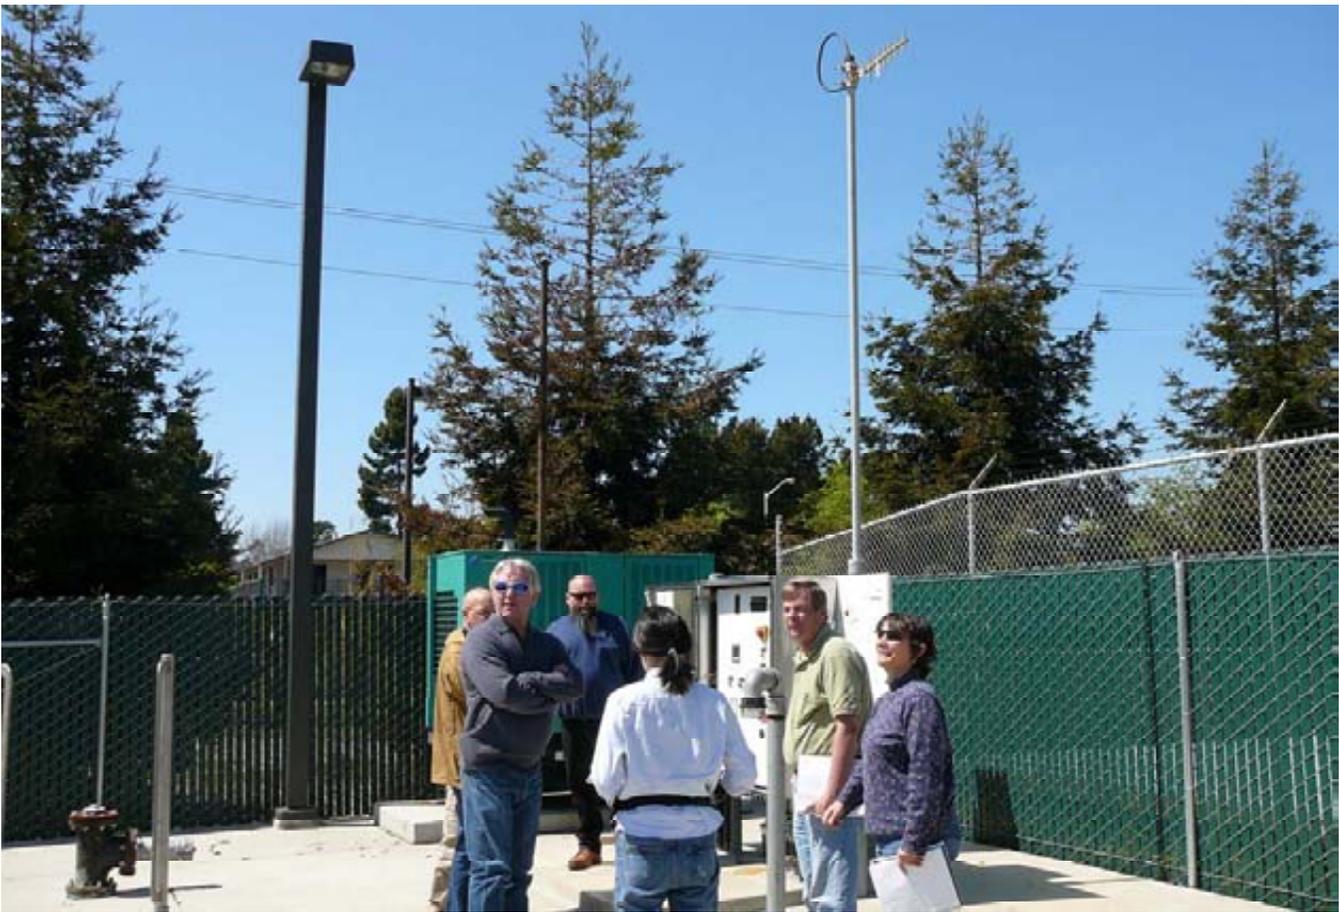
- Lift Station 6 (Photos 11 and 12) – located next to new Coast Guard housing. This is the newest station. It is fenced. SCADA is present. The new force main from this station was broken by a backhoe during installation of irrigation piping. The spill entered a storm water detention pond and was recovered. The spill was reported three times during the period 11/7-8/06, for a combined volume of 7,900 gallons.

City staff stated that there was a spill due to a force main break from Lift Station 6 (Photos 11 and 12) on 11/7-8/2006. The spill entered a storm water detention pond and was fully recovered. This spill was not reflected in the table above filled out by the City. City staff believed that the force main break was indicated as one of the two spills for 2006 from pump stations, but review of the reported spills indicates that there were two pump station spills in 2006. Therefore, SAIC has added the force main spill to the tables above.

Alameda Photo 11 - Lift station 6

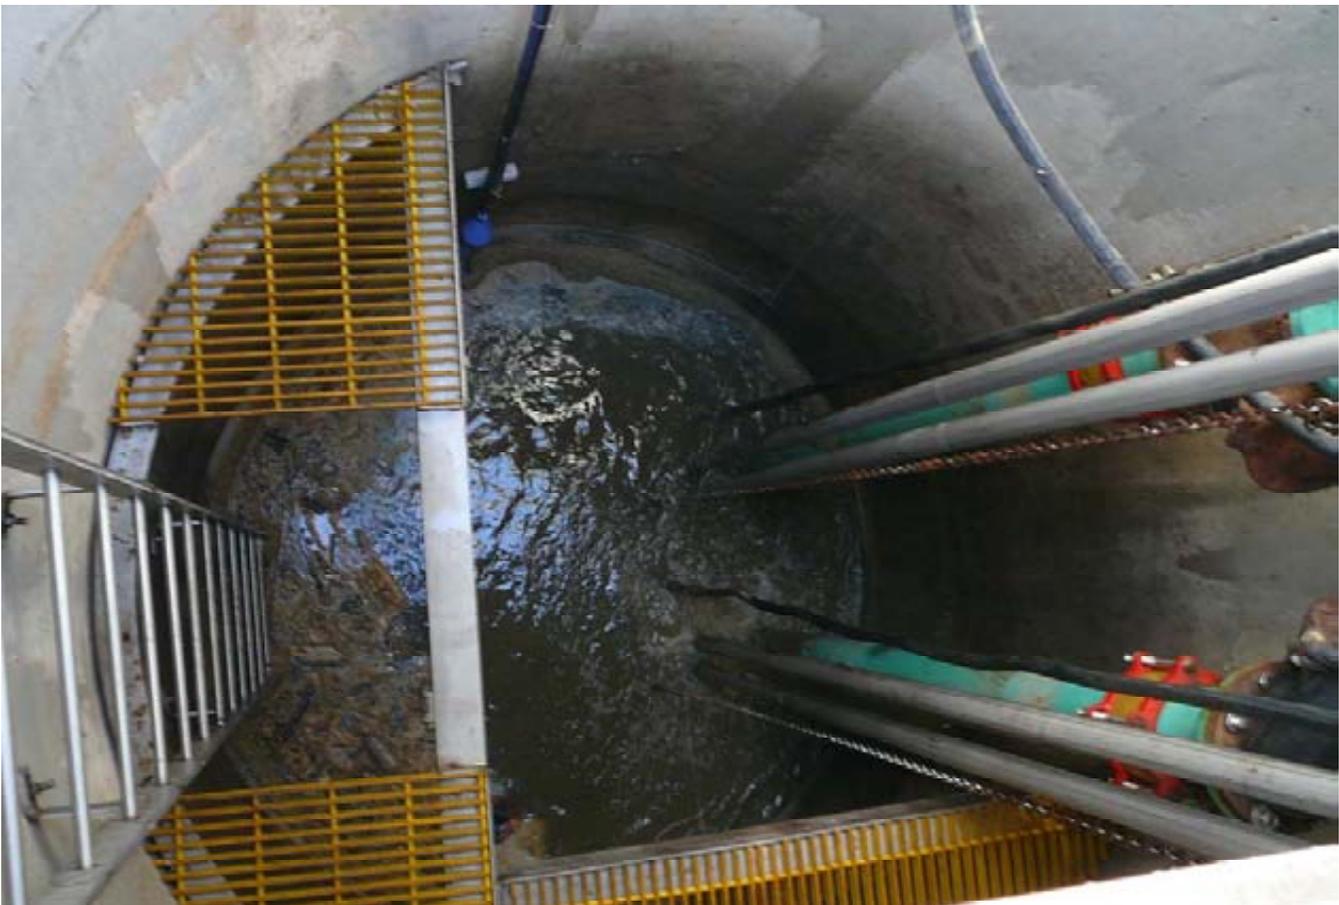
Alameda Photo 12 - Lift station 6 wet well

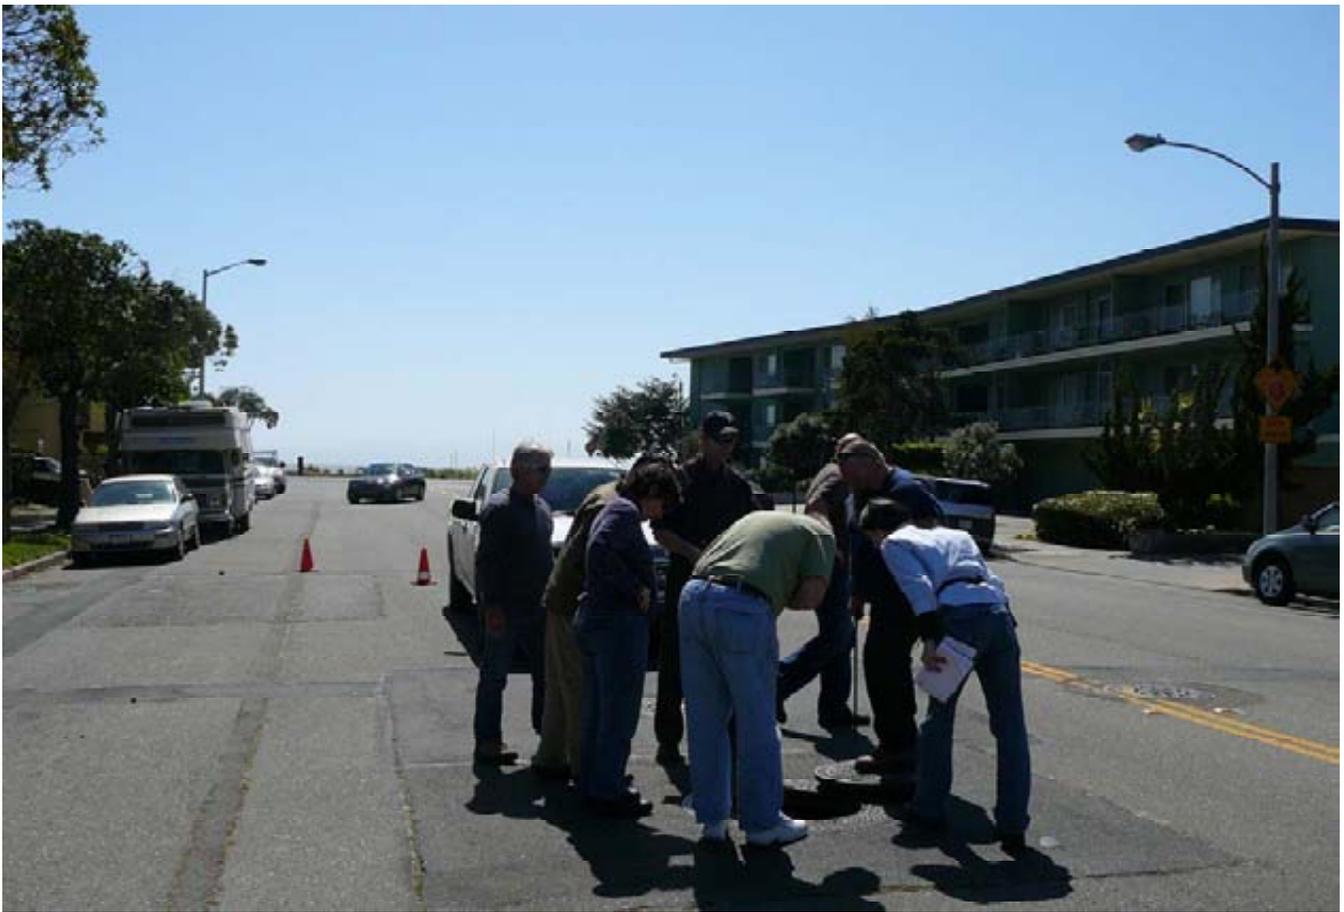
- Willow (Photos 13 – 15) – located in street in residential area near San Francisco Bay. SCADA is present. Any overflow from this station would flow by gravity back to a sewer main.

Alameda Photo 13 - Willow pump station

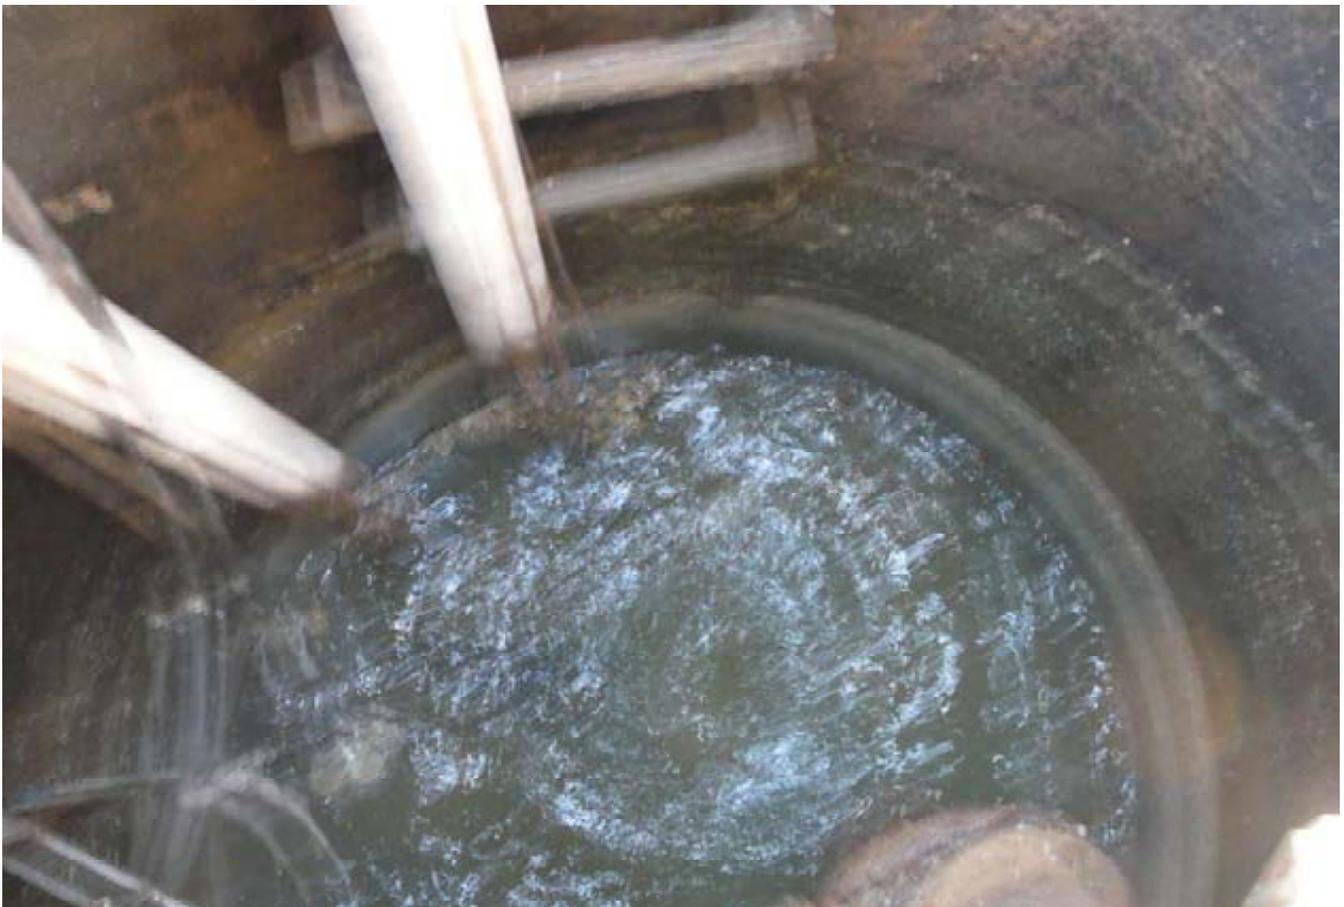
Alameda Photo 14 - Willow pump station wet well

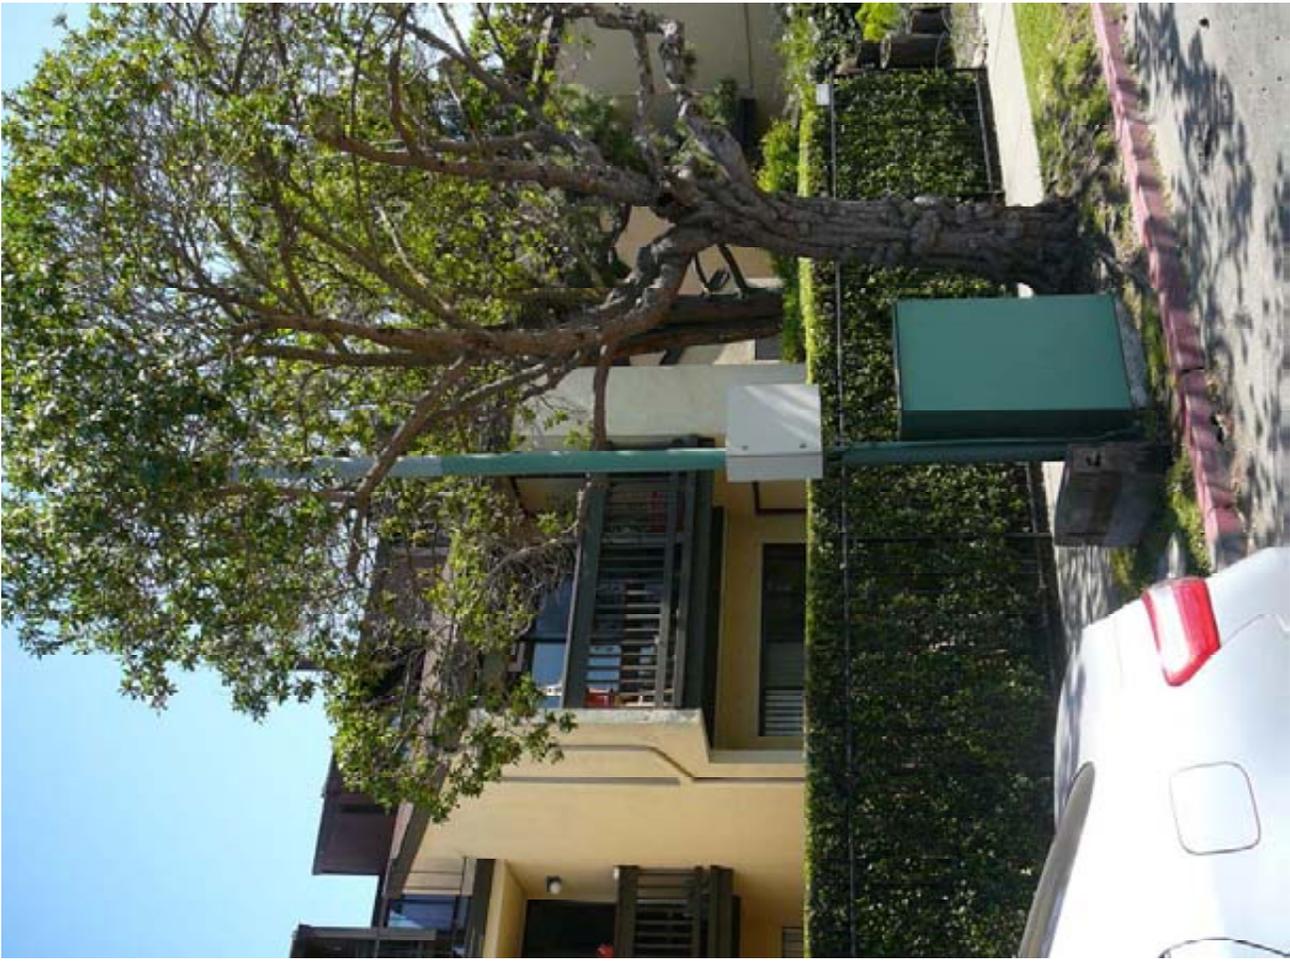
Alameda Photo 15 - Willow pump station SCADA

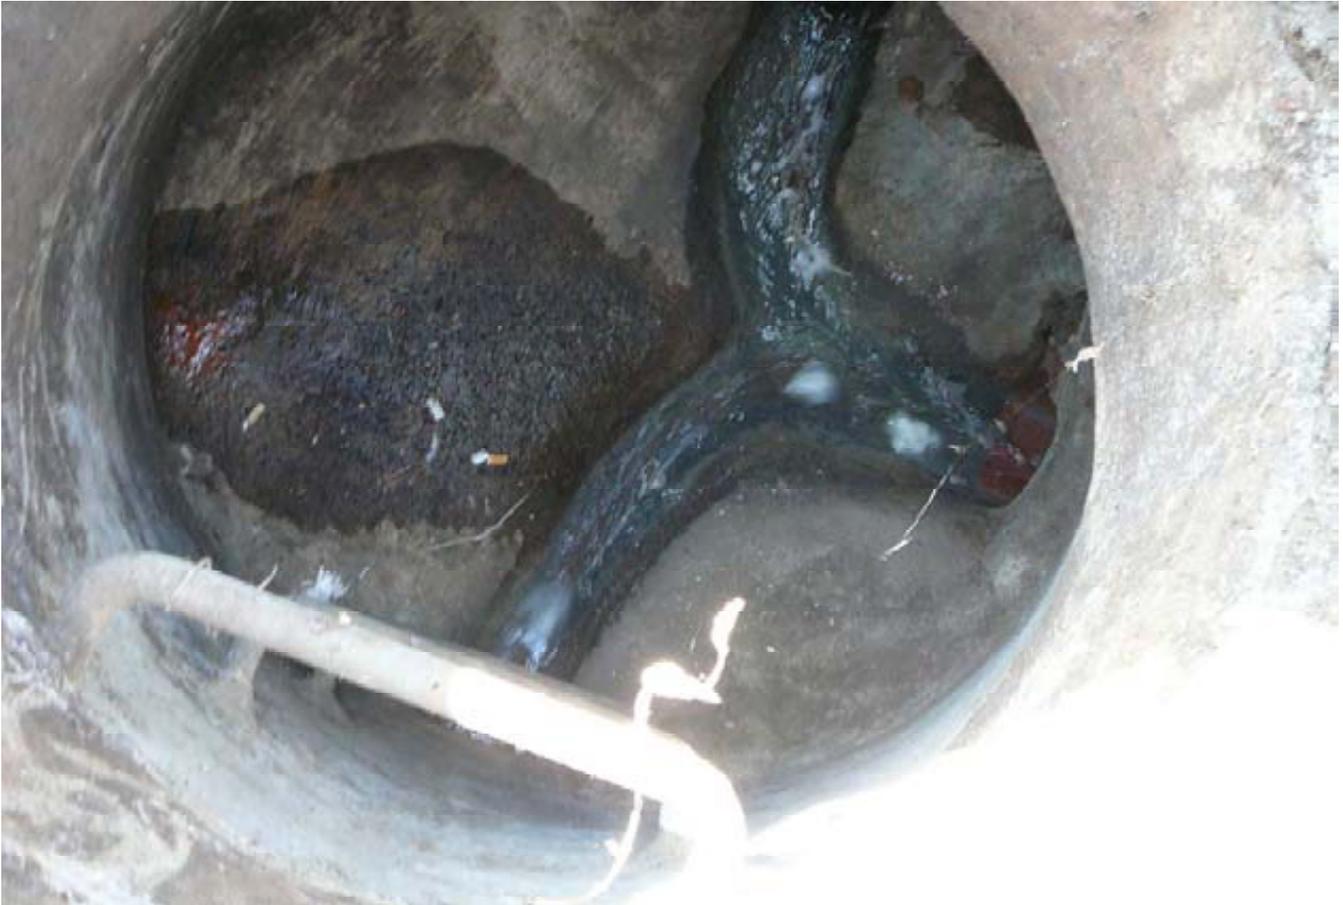
The three spills at 100 and 300 Kitty Hawk Road were due to grease from several apartment complexes at these locations. The inspection team visited the manhole that overflows (Photo 16). City staff stated that they now clean the main every three months to prevent further spills. They have also cooperated with EBMUD to do outreach on grease issues to the nearby residents.

Alameda Photo 16 - Kitty Hawk spill site manhole

SAIC added one location to the hot spot cleaning schedule table above, because the City stated that they clean the Kitty Hawk spill site quarterly.
